Performance of naturally durable eucalypt posts in Marlborough vineyards.

Authors: Paul Millen and Clemens Altaner

Date: 26th October 2017

Publication No: SWP-T039

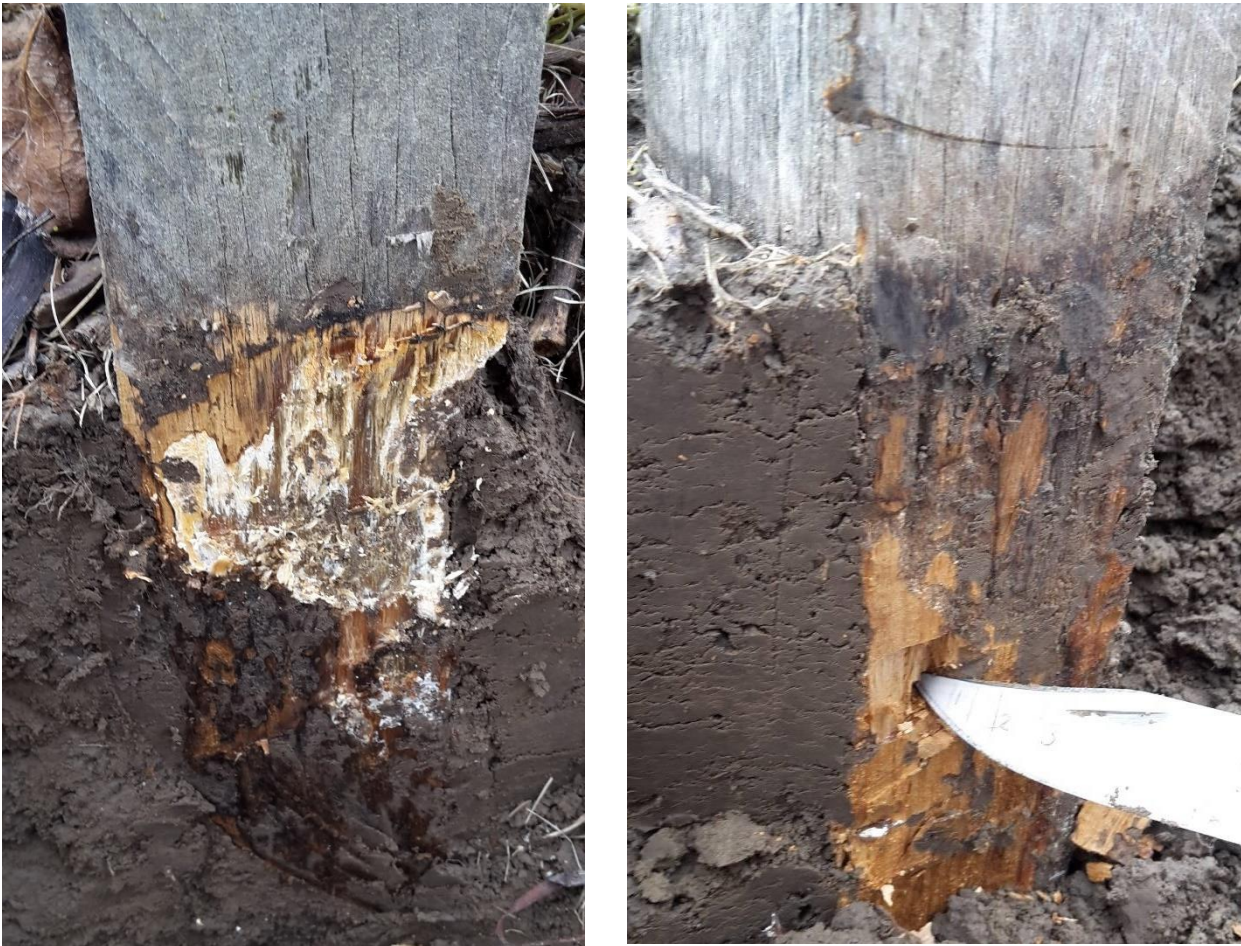
White-rot and brown-rot (and possibly soft-rot) were found on posts of both species (Figure 3).

Figure 3: White-rot (left) and brown-rot (right) on *E. bosistoana* posts after 10 years in service (post 36 and 40)

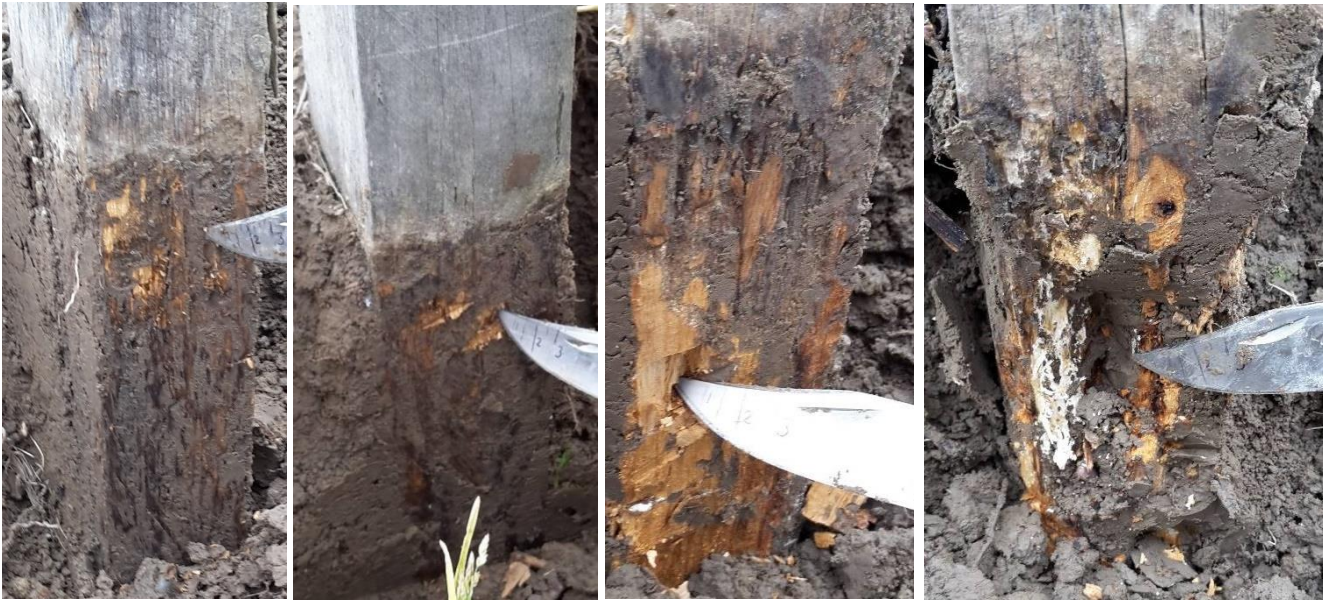
E. bosistoana posts performed well at both assessed sites (Figure 5) with many posts showing no sign of decay. The full range of decay assessed in *E. bosistoana* posts is shown in Figure 6. This is what would be expected as there is natural variation in the decay rates of wood from different trees of the same species as well as variation in the wood in different parts of the stem. These natural variations are noted in the Australian Standard AS5604 as '*the inner heartwood (the first few growth rings around the pith), generally, has lower natural durability than the rest of the heartwood*'.

Figure 6: Range of decay in *E. bosistoana* posts after 10-11 years in service. From left to right: < 2mm; 2-5 mm; 10-20 mm; > 30mm (post 10, 21, 40 and 41). Note: post 41 showed the severest decay of all assessed *E. bosistoana* posts.

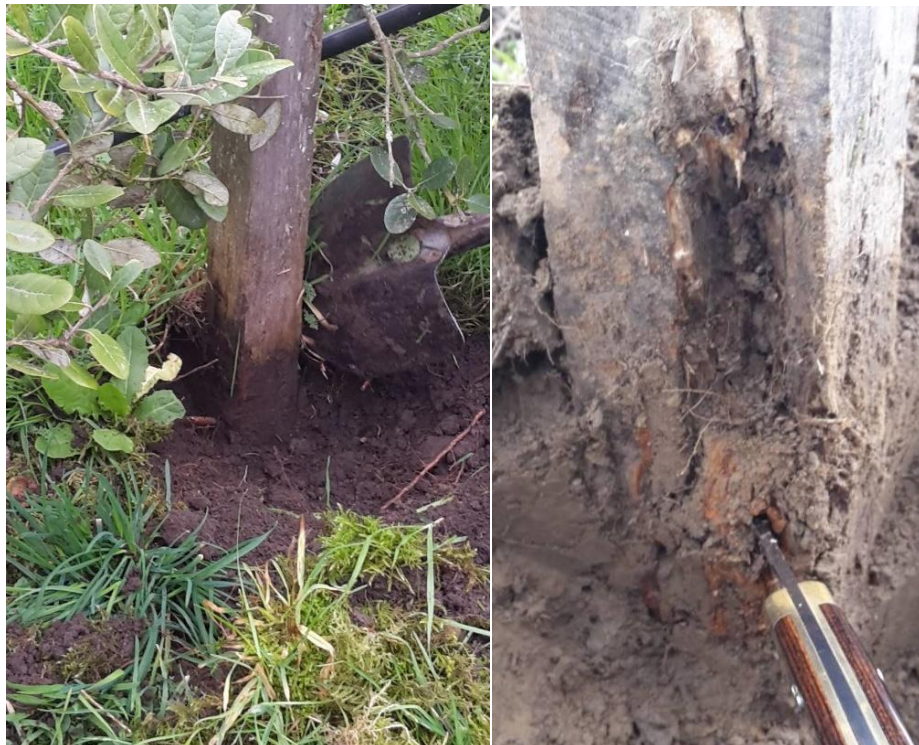
Performance of *E. globoidea* was site specific (Figure 8). After 10 years in service posts at vineyard 2 showed severe decay while posts in the feijoa orchard at vineyard 3 (also in service for 10 years) were performing well (Figure 9). One possible site effect is the under-vine cultivation at vineyard 2 compared to the undisturbed soil at vineyard 3.

Figure 9: *E. globoidea* posts after 10 years in service. Post 116 in feijoa orchard at vineyard 3 showing no sign of decay and failed post 62 at vineyard 2. Note: Post 62 showed the severest decay of all assessed *E. globoidea* posts.

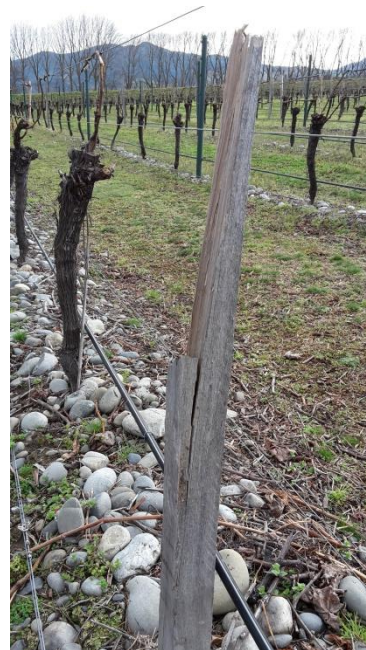
Figure 16: *E. bosistoana* post broken by machine harvester in vineyard 1.

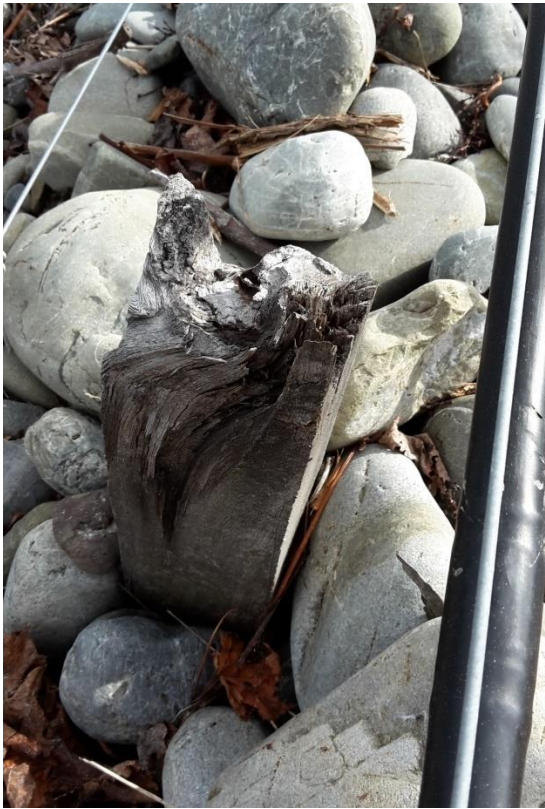
Figure 17: *E. bosistoana* post broken across knot in vineyard 1.

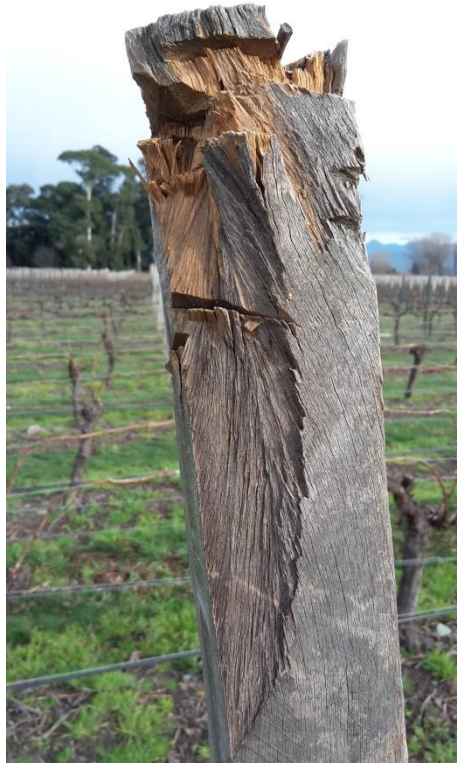
Figure 18: *E. bosistoana* showing repeated damage by machine harvester in vineyard 1.

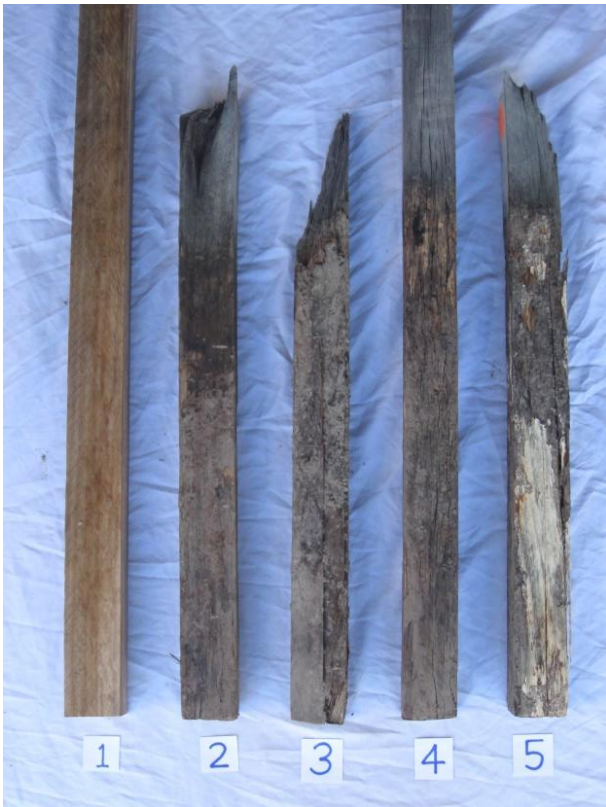
Figure 19: Sections of *E. bosistoana* posts with no. 1 unused timber and no's 2,3,4 & 5 all sections of broken posts dug out of vineyard 1 after 10 years in ground. Note no. 5 is pith wood.

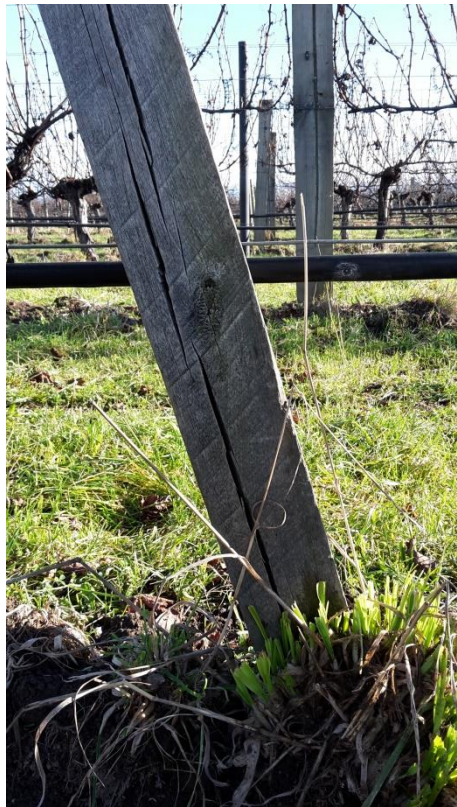
Figure 20: Broken half round CCA pine post in vineyard 2.

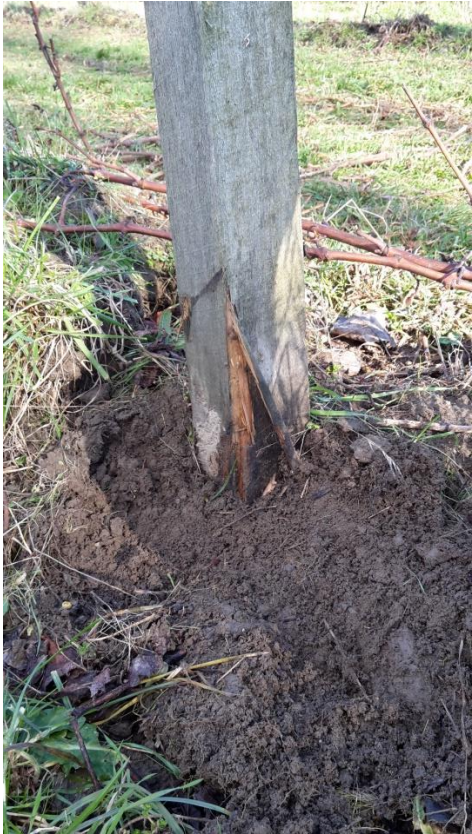
Figure 21: *E. globoidea* post with recent damage by mechanical undervine cultivation in vineyard 2.

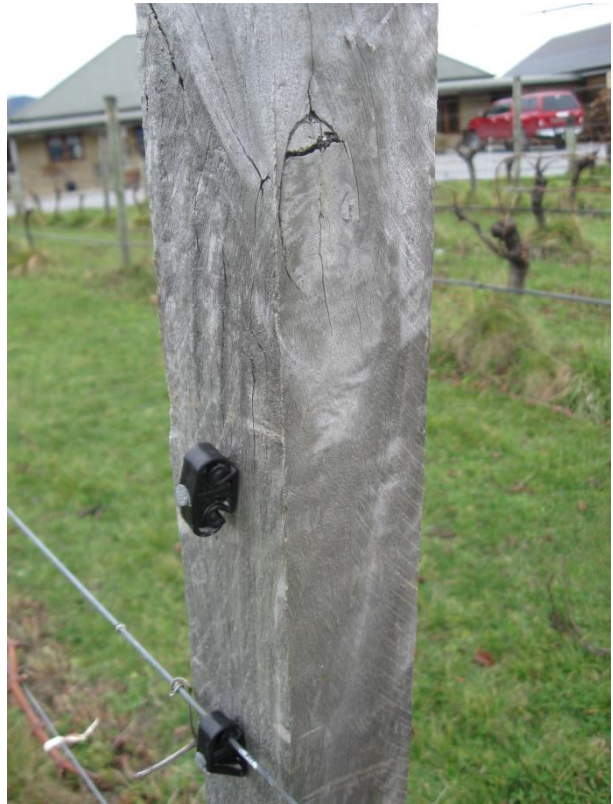
Figure 24: *E. globoidea* showing wire hangers fastened with clouts at vineyard 4c. Note the size of the spike knot.

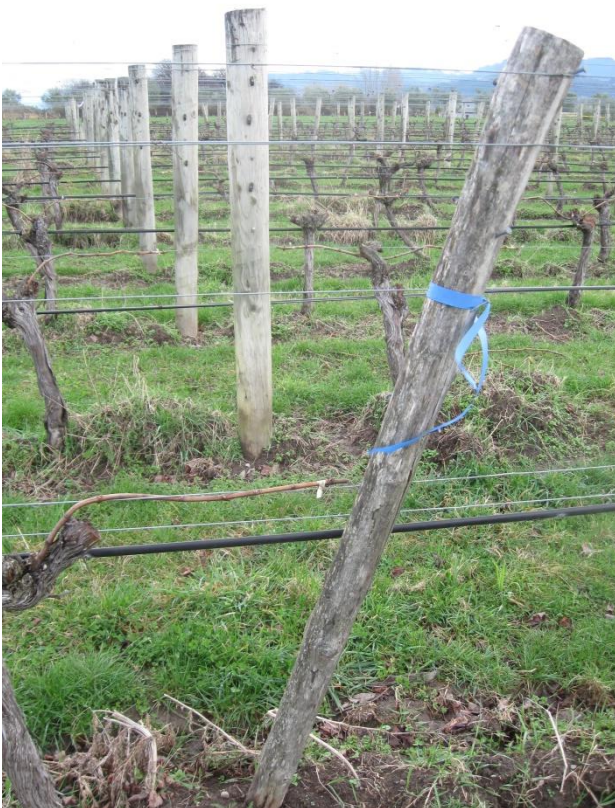
Figure 30: Imported teak round post decayed at just below ground level and marked for replacement in vineyard 5.

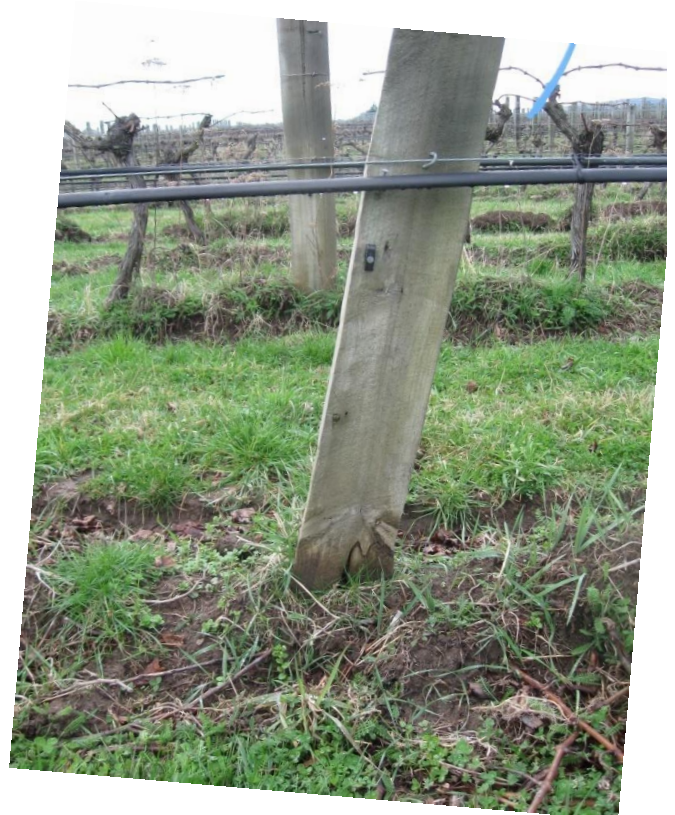
Figure 31: CCA treated pine post cracked across branch whorl at ground level and marked for replacement in vineyard 5.

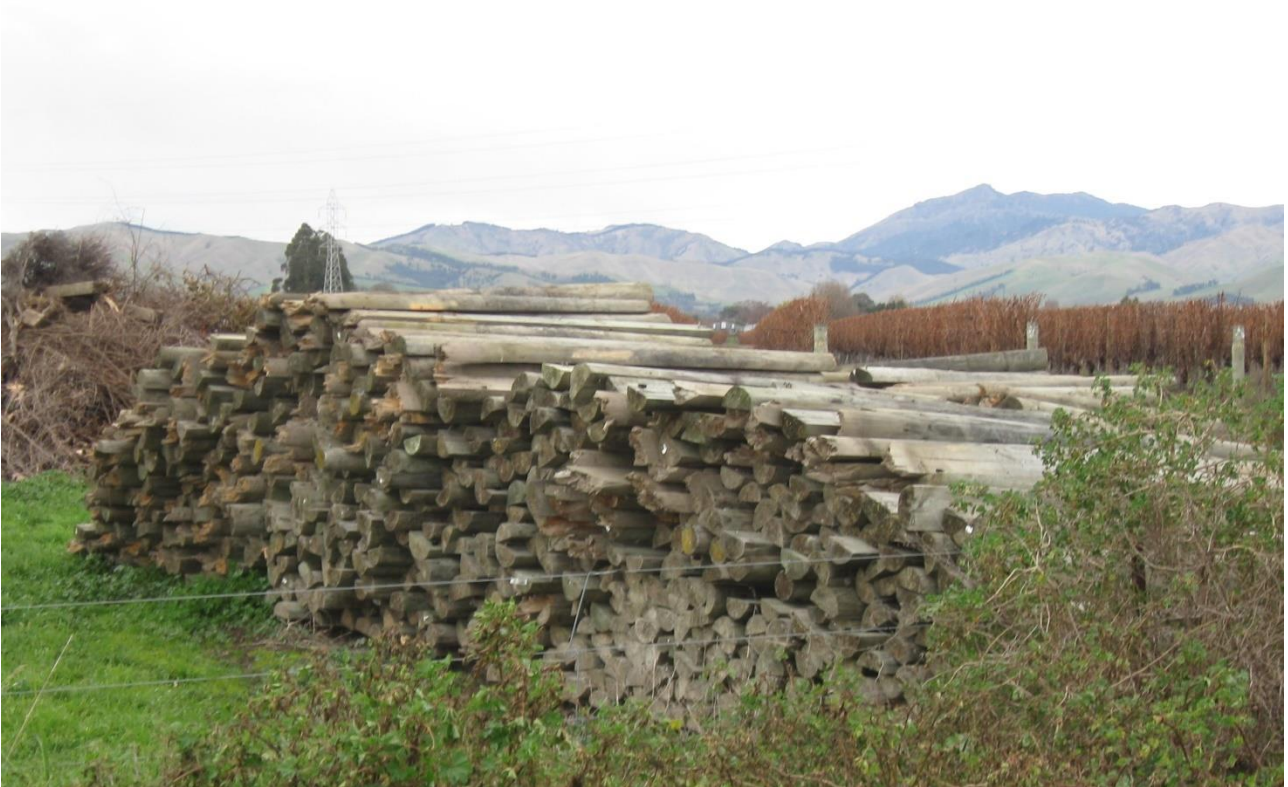
Figure 32: View of broken CCA post stock pile in an adjoining vineyard to one of those assessed.

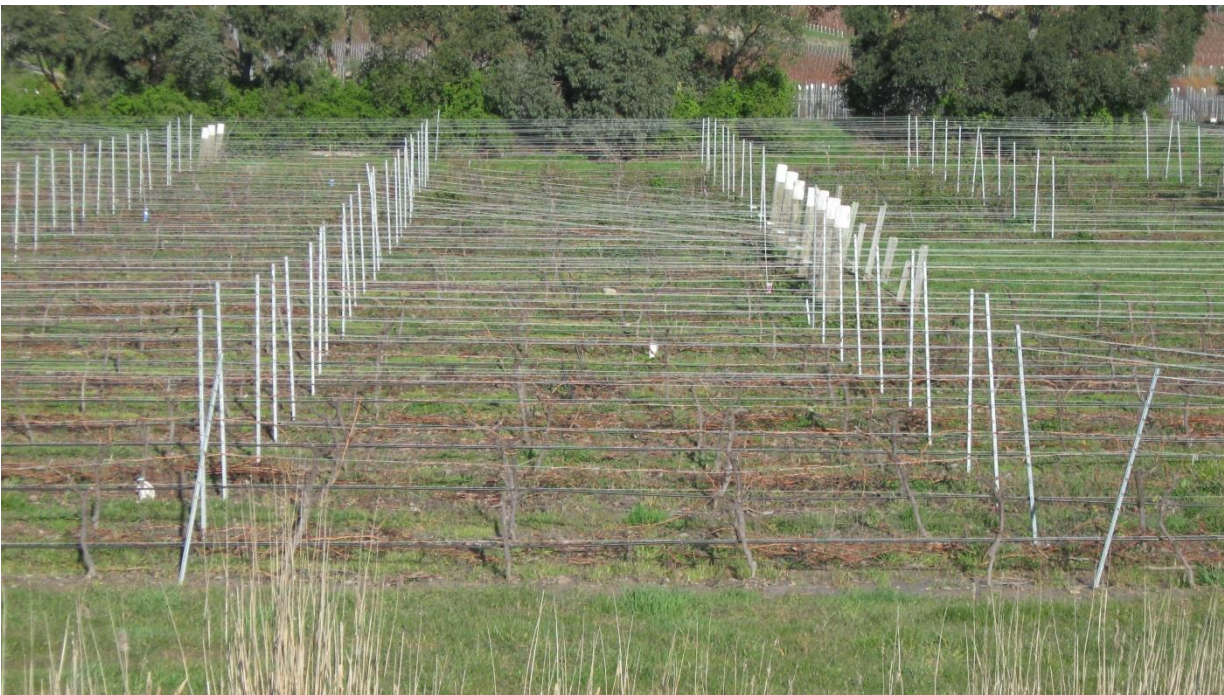
Figure 33: View of a Marlborough vineyard using all steel posts with some showing the impact of machine harvesting.
