The condition of thermally modified cypress and Douglas fir decking after one year's field exposure

Authors: Ian Simpson and Tripti Singh

Date: May 2023

Publication No: SWP-T172

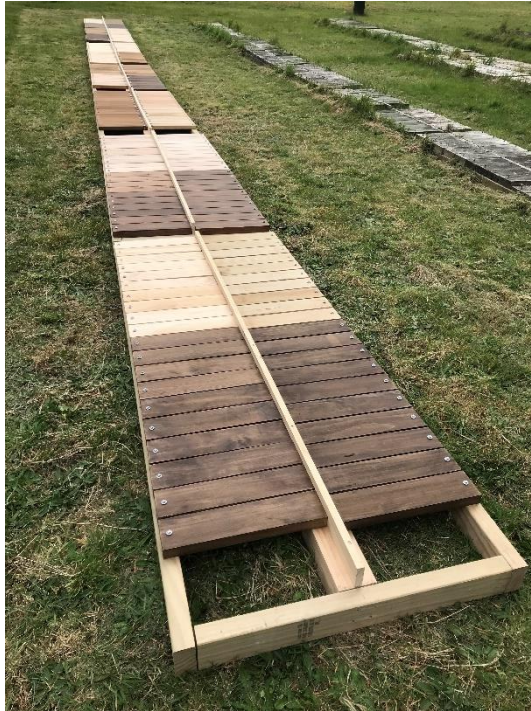
Figure 1: General view of decking trial at the time of installation (September 2021).

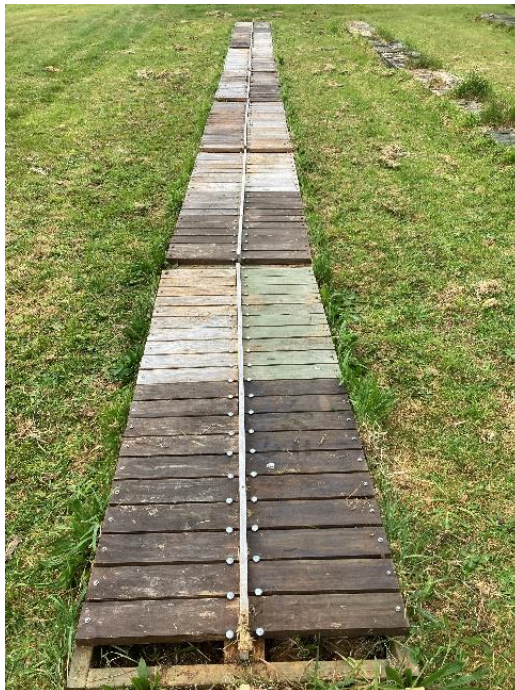
Minor surface checking was observed on many of the samples. The surface of unstained samples had turned a light silver/grey colour, and there was some loss of stain on the stained samples.

Figure 2: General view of decking trial after one years exposure (September 2022).
