# The condition of Cypress with or without thermal modification L-joints after one year's field exposure

**Date:** May 2023

Publication No:SWP-T173

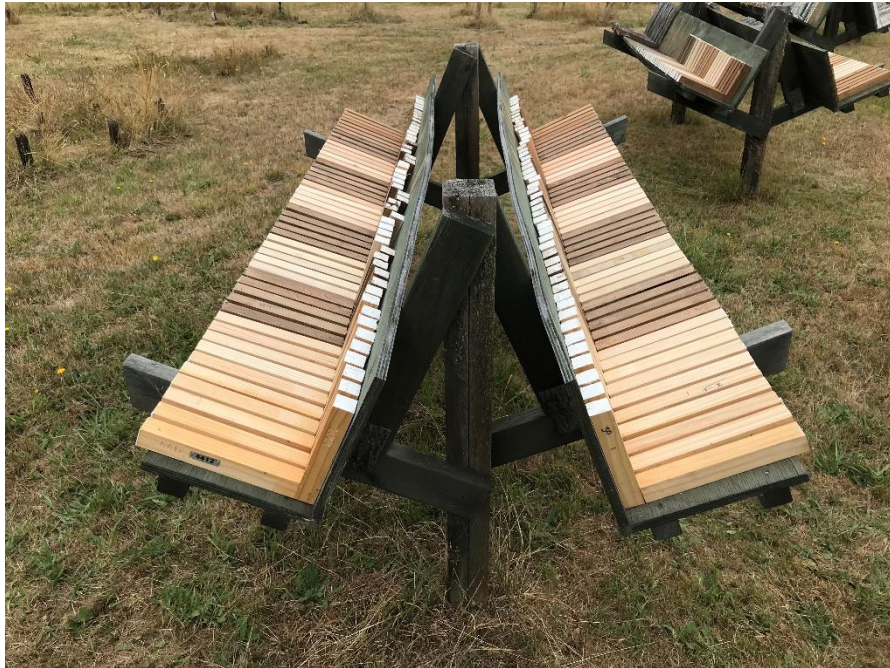
**Figure 1:** General view of L-joint trial at the time of installation (February 2022).

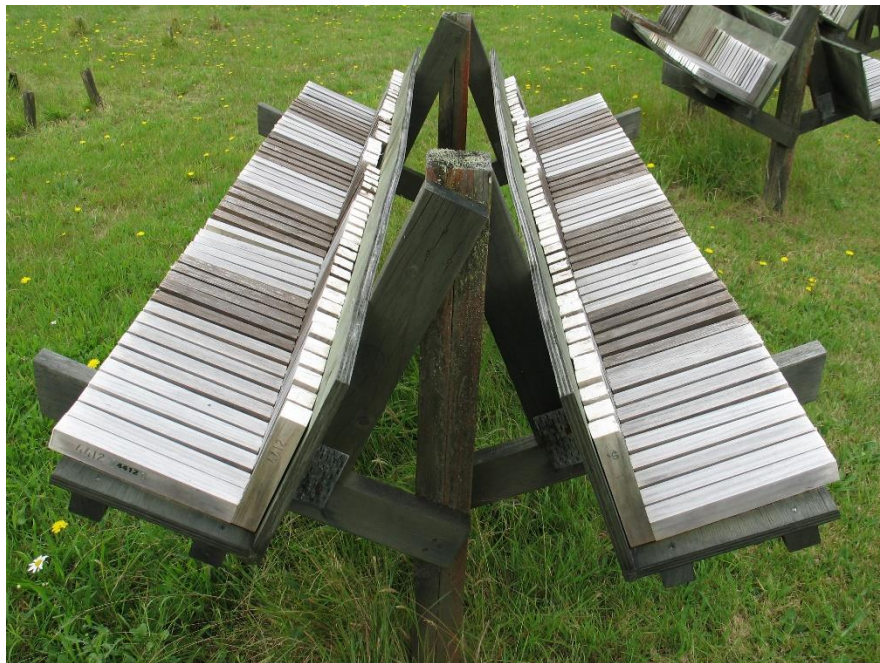
No decay was observed on any of the untreated or thermally modified *Cupressus lusitanica* L-joint samples in this test. The surface of the samples had turned a grey/silver colour (Figure 2). Surface checking was very minor.

No decay was observed on any of the Accoya radiata pine L-joint samples in this test. The surface of the samples had turned a grey/silver colour (Figure 2). No surface checking was observed.

No decay was observed on any of the untreated or treated (H3.1 LOSP and H3 CCA) radiata pine L-joint samples in this test. The surface of the samples had turned a grey/silver colour (Figure 2). Surface checking was very minor.

**Figure 2:** General view of L-joint trial after one year's exposure (February 2023).
