Performance of naturally durable eucalypt posts in Marlborough vineyards.

Authors: Paul Millen and Clemens Altaner

Date: 26th October 2017

Publication No: SWP-T039

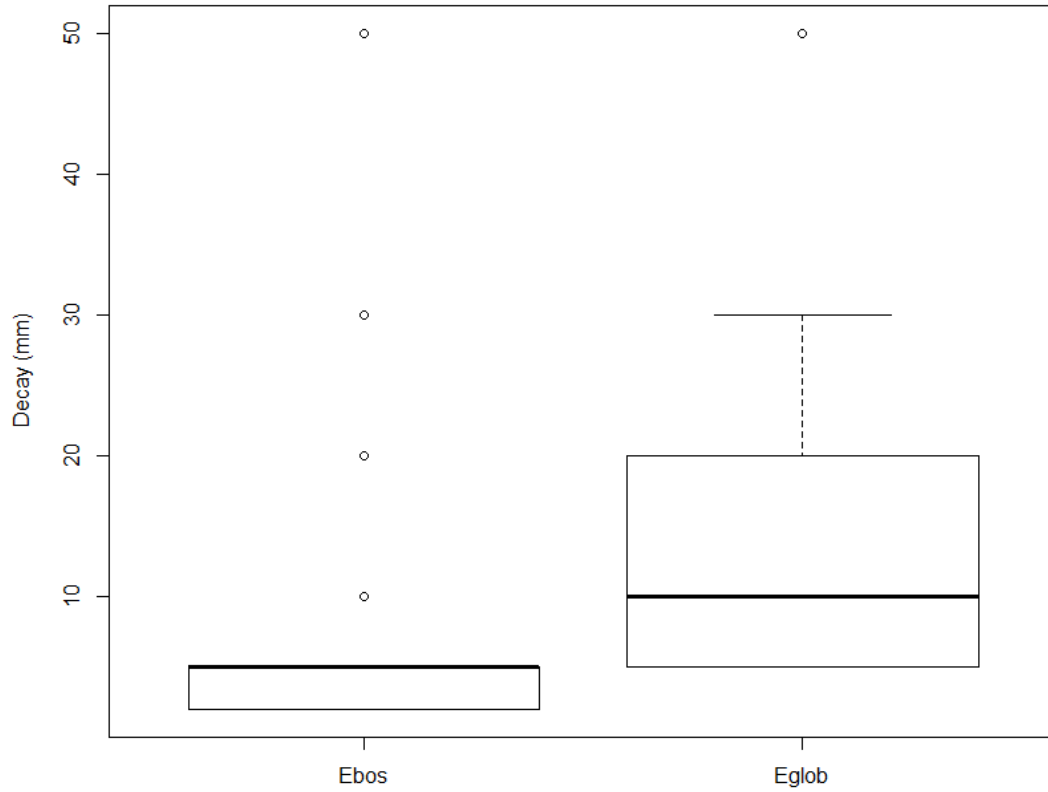
Figure 4: Decay depth of *E. globoidea* (n=63) after 10 years and *E. bosistoana* (n=73) posts after 9-11 years in service. Note: confounded by site.

Generally, *E. bosistoana* posts showed less decay than *E. globoidea* posts after 9 -11 years in service (Figure 4). However, this analysis was confounded by site, as not all sites had posts from both species.

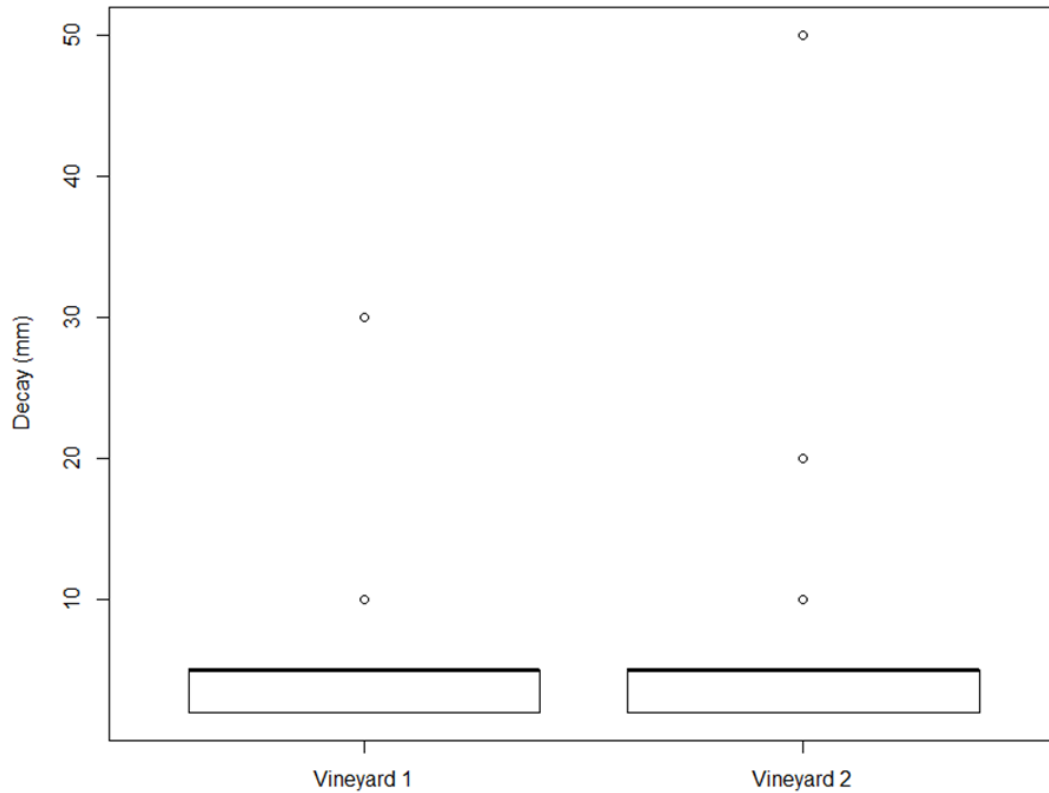
Figure 5: Decay depth of *E. bosistoana* posts at vineyard 1 (n=50) after 10 years and vineyard 2 (n=23) after 9-11 years in service.

E. bosistoana posts performed well at both assessed sites (Figure 5) with many posts showing no sign of decay. The full range of decay assessed in *E. bosistoana* posts is shown in Figure 6. This is what would be expected as there is natural variation in the decay rates of wood from different trees of the same species as well as variation in the wood in different parts of the stem. These natural variations are noted in the Australian Standard AS5604 as '*the inner heartwood (the first few growth rings around the pith), generally, has lower natural durability than the rest of the heartwood*'.

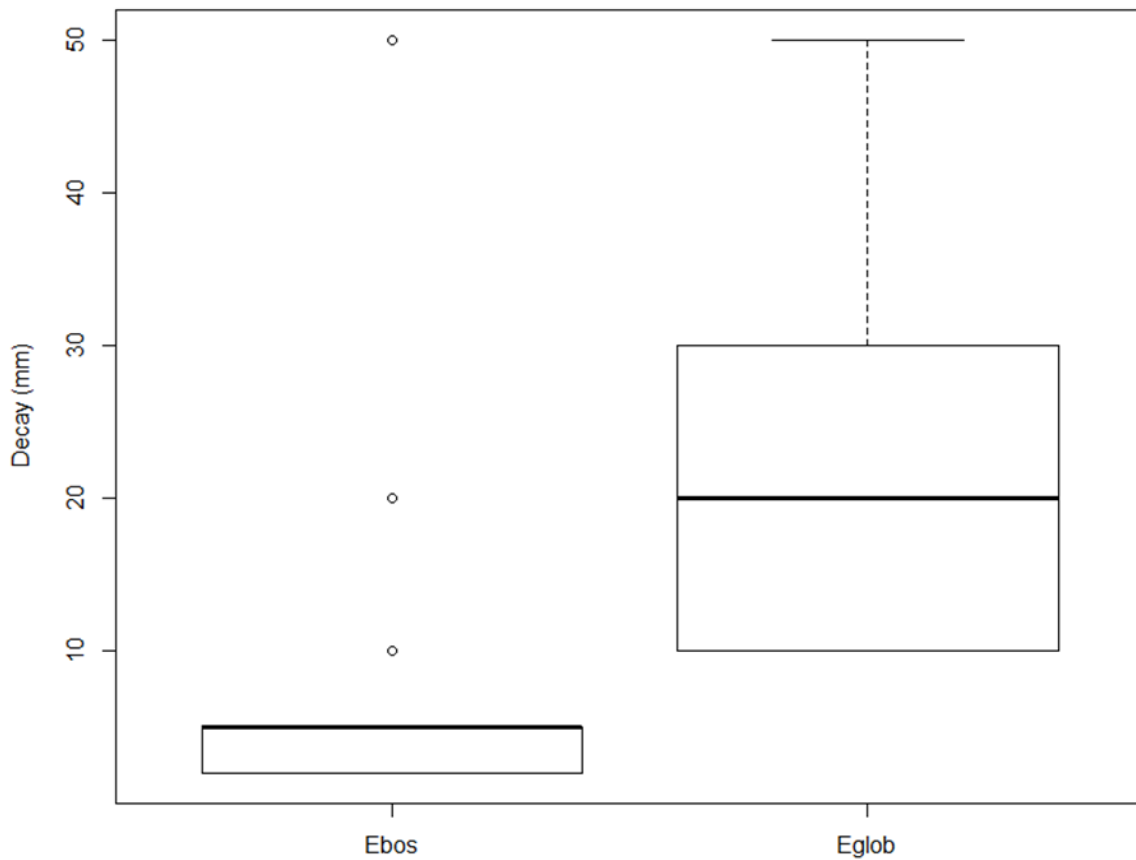
Figure 7: Decay depth of *E. globoidea* (n=25) and *E. bosistoana* (n=23) posts after 9-11 years in service.

Vineyard 2 had posts of both species present and clearly showed the better performance of *E. bosistoana* (Figure 7).

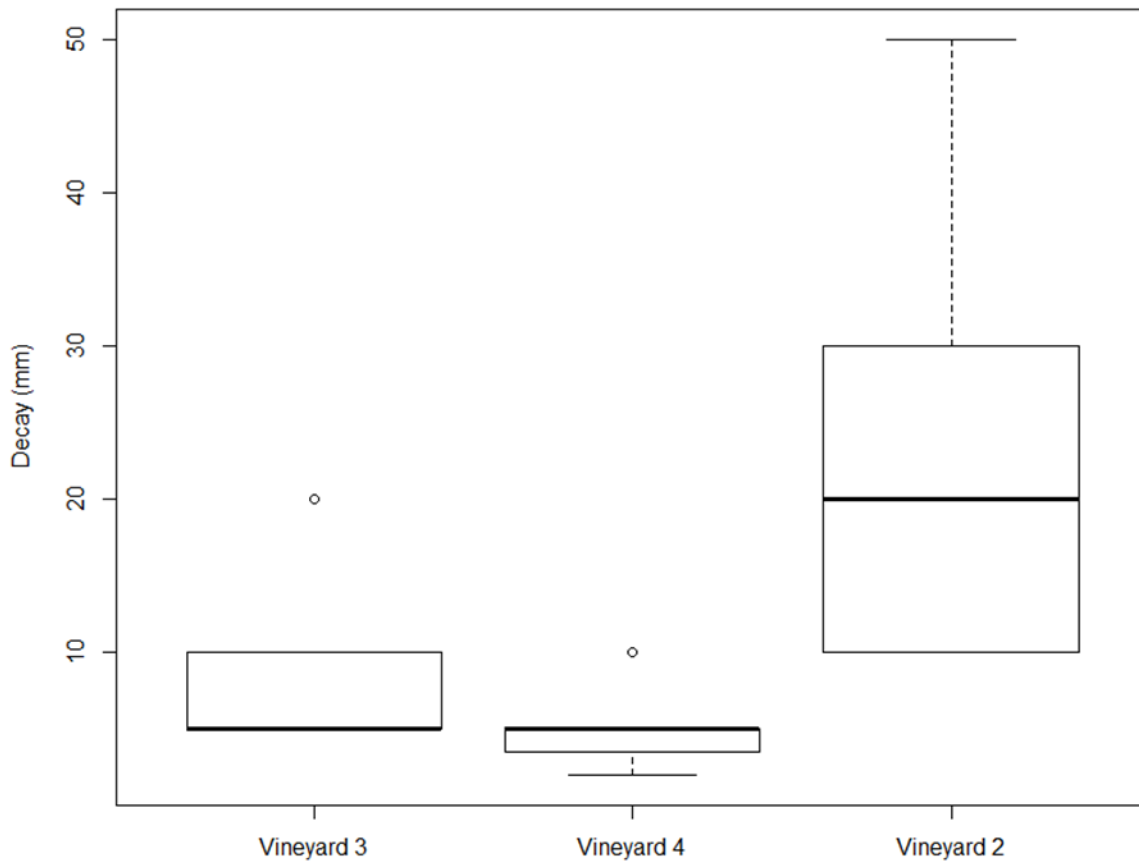
Figure 8: Decay depth of *E. globoidea* posts at vineyard 3 (n=38) after 10 years; vineyard 4 (n=12) after 5 years and vineyard 2 (n=25) after 10 years).

Performance of *E. globoidea* was site specific (Figure 8). After 10 years in service posts at vineyard 2 showed severe decay while posts in the feijoa orchard at vineyard 3 (also in service for 10 years) were performing well (Figure 9). One possible site effect is the under-vine cultivation at vineyard 2 compared to the undisturbed soil at vineyard 3.

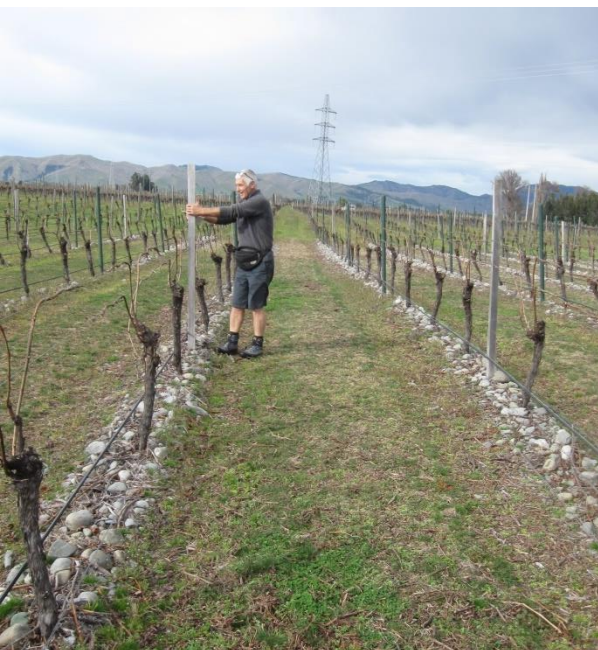
Figure 15: In service assessment using the 'pull' test at vineyard 1.

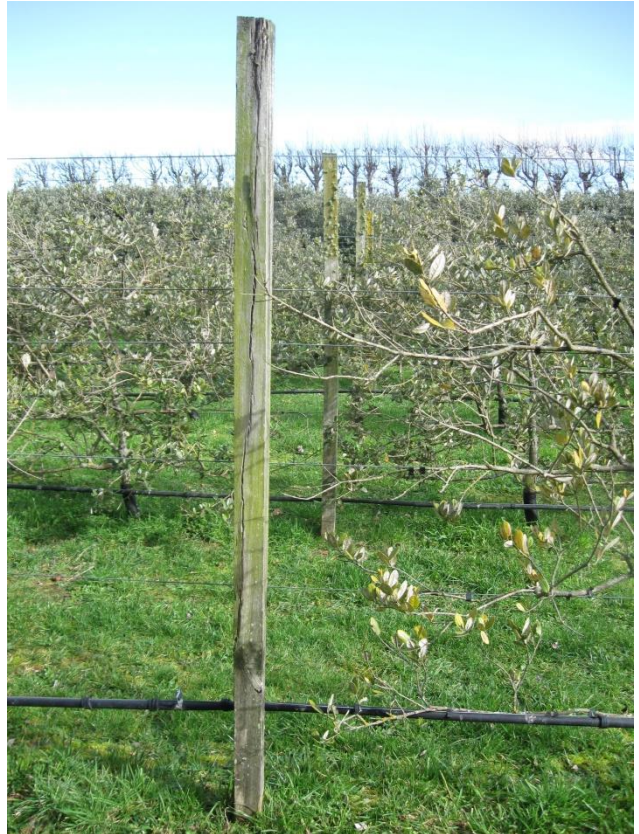
Figure 22: *E. globoidea* post in feijoa orchard. This one is sawn through the centre of the stem as the line of the pith is evident.

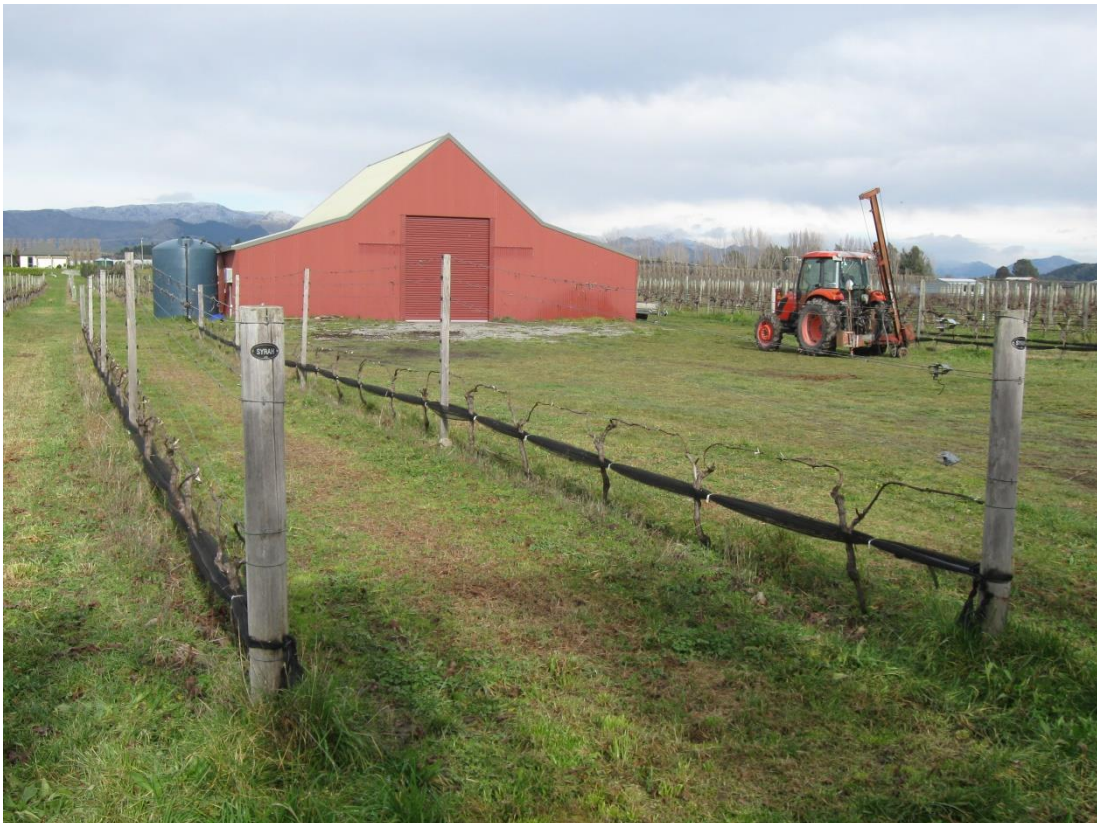
Figure 27: View at vineyard 4a of small vineyard area with E. globoidea trellis posts and Wallaba strainers. Wallaba are imported naturally durable posts that were available in Marlborough through local rural supply agents. This small area of vineyard was part of the in ground post assessment.

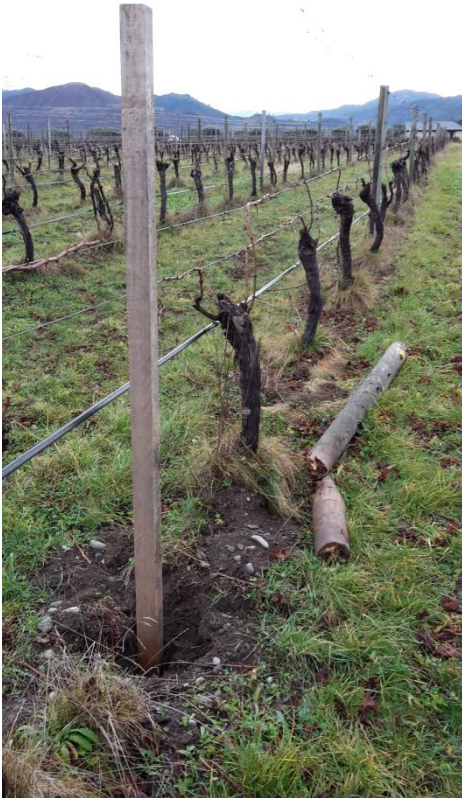
Figure 28: New *E. paniculata* post being installed to replace broken CCA post in vineyard 4a.
