# *The decay resistance of alternative species in an accelerated framing test*

## *Assessment of decay after one year's exposure*

Publication No: SWP-T160

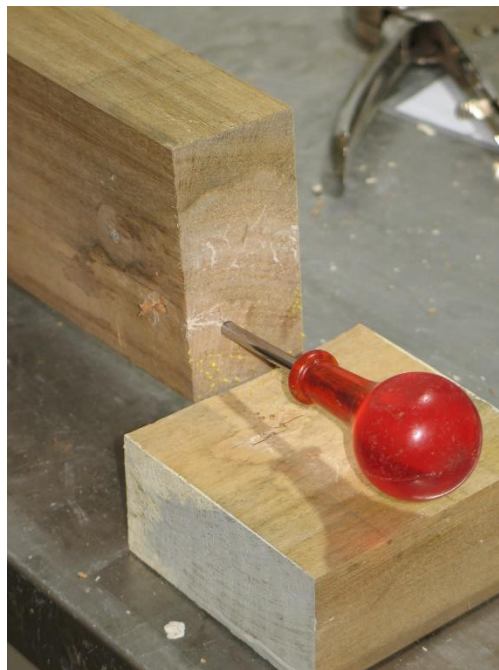
**Figure 2:** Severe decay in the joint of untreated *Eucalyptus fastigata* after one year's exposure (sample 13).

After one year's exposure, moderate mycelium growth was observed on many of the untreated *Eucalyptus fastigata* samples. The presence of mycelium does not necessarily indicate the presence of wood decay. The early stages of decay were observed on the surface and in the joint of many samples, with higher levels of decay observed at the end of the sample with the *Antrodia xantha* (Ax) feeder block (Figure 2).

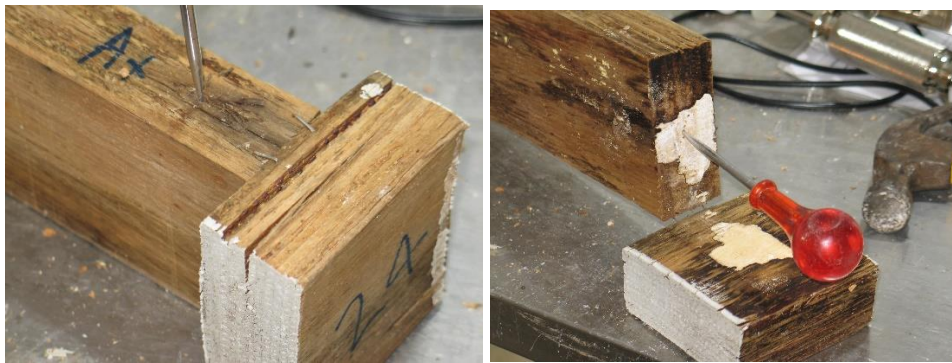
**Figure 4:** Lightly established decay on the edge and in the joint of untreated *Eucalyptus fastigata* LVL after one year's exposure (sample 24).

Established decay was observed on some of the untreated *Eucalyptus fastigata* LVL samples (Figure 4). Mould was not observed on the *Eucalyptus fastigata* LVL samples.

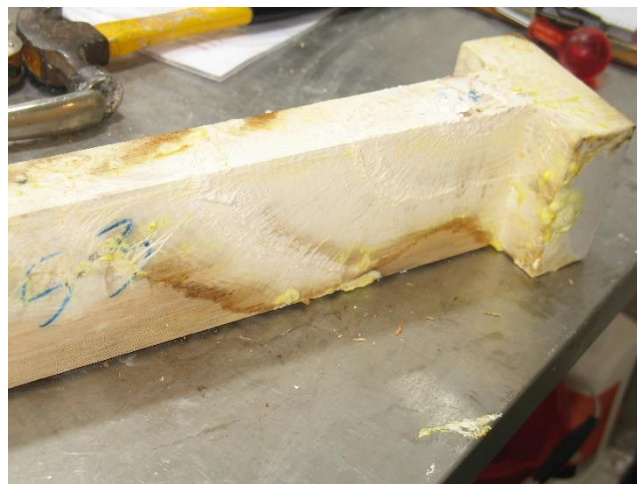
**Figure 5:** Extensive mycelium over half of the surface of an untreated *Eucalyptus nitens* sample after one year's exposure (sample 53).

Many of the untreated *Eucalyptus nitens* samples had extensive mycelium growth (Figure 5) but no mould growth was observed. The first stages of decay or lightly established decay was observed on the surface and in the joint of many of the untreated *Eucalyptus nitens* samples (Figure 6).

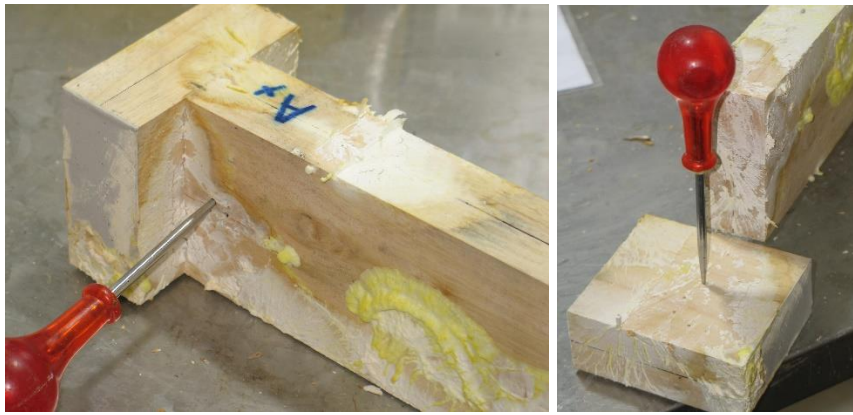
**Figure 6:** Lightly established decay on the surface and in the joint of an untreated *Eucalyptus nitens* sample after one year's exposure (sample 57).

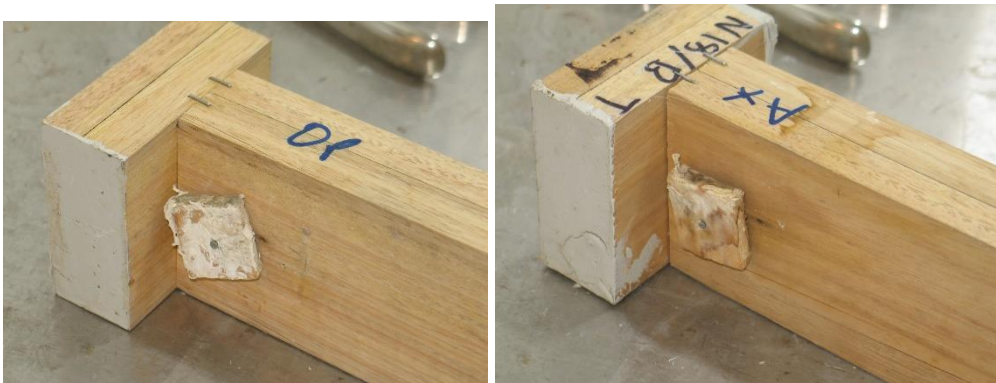
**Figure 7:** No mould, mycelium or decay on the surface of boron treated *Eucalyptus nitens* sample after one year's exposure (sample 47).

Less mycelium was observed on the boron treated *Eucalyptus nitens* samples. No decay was observed on any of the boron treated *Eucalyptus nitens* samples (Figure 7).

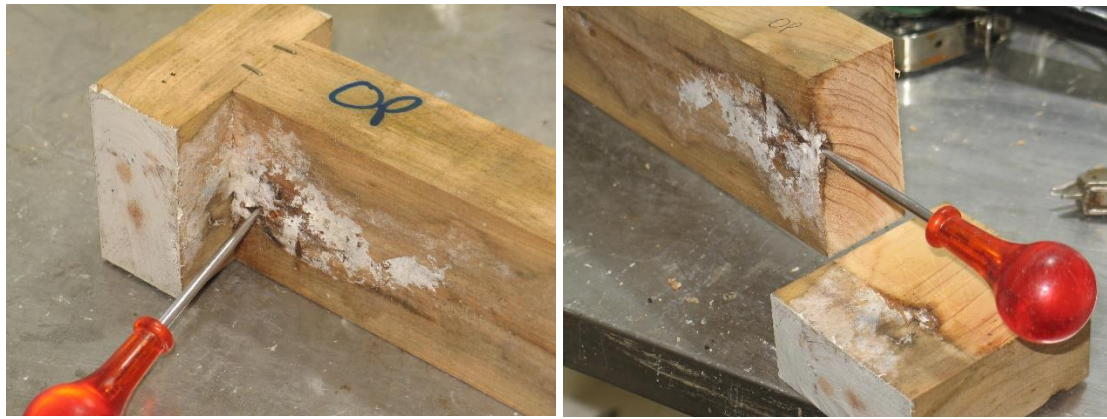
**Figure 9:** Decay on the surface and in the joint of an untreated *Cupressus macrocarpa* sample from an old tree, after one year's exposure (sample 84).

Higher levels of mycelium was observed on the untreated *Cupressus macrocarpa* from the old trees than from the young trees. The first stages of decay was observed at the Op feeder block on some of the *Cupressus macrocarpa* from the old trees (Figure 9). Decay was observed on one of the *Cupressus macrocarpa* from the young trees.

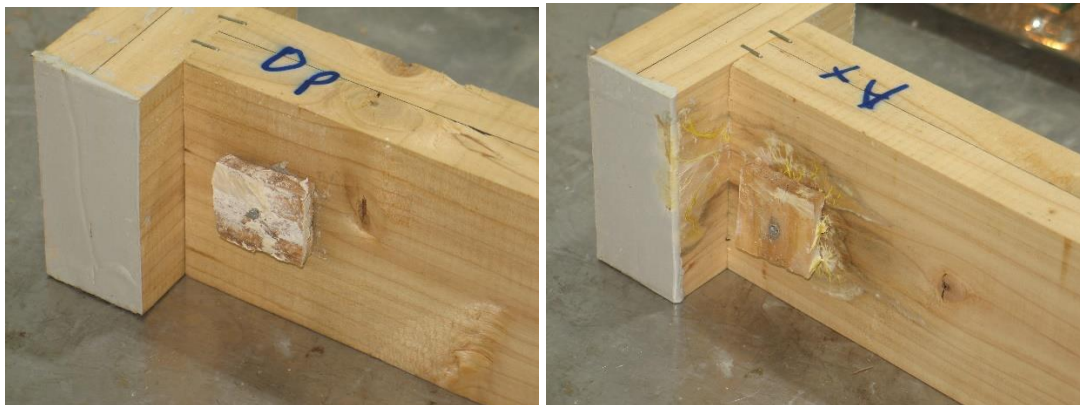
**Figure 10:** No mycelium growth at the Op feeder block and moderate mycelium growth at the Ax feeder block of an untreated *Cupressus x ovensii* sample after one year's exposure (sample 108).

Mycelium growth was observed on *Cupressus x ovensii* samples around the Ax feeder block (Figure 10) and the first stages of decay were observed on some of the untreated *Cupressus x ovensii* samples at the end with the Ax feeder block. No mould was observed on any of the *Cupressus x ovensii* samples.

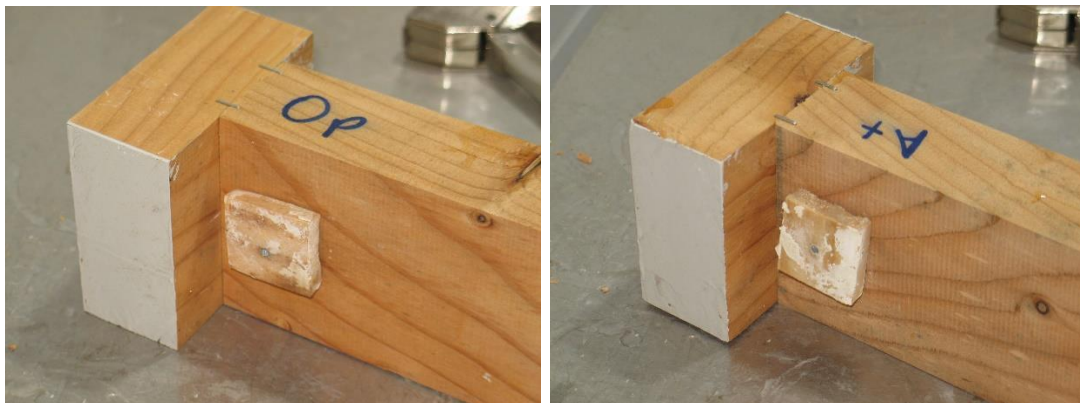
**Figure 11:** No mycelium or mould growth, or decay, on an untreated *Larch* sample after one year's exposure (sample 115).

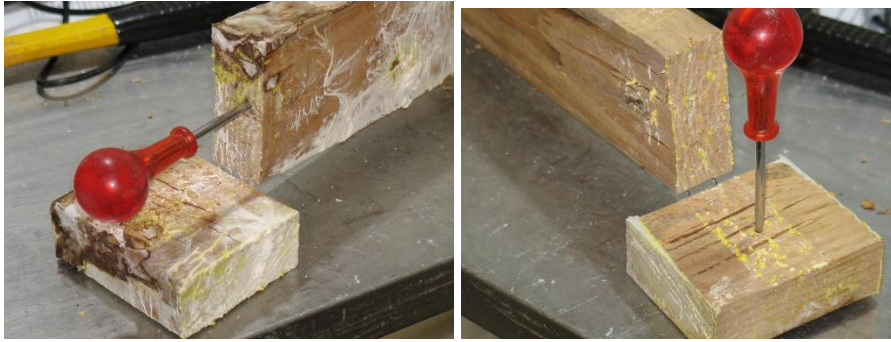
**Figure 12:** Well established decay in the joints of an untreated *Douglas fir* sample after one year's exposure (sample 125).

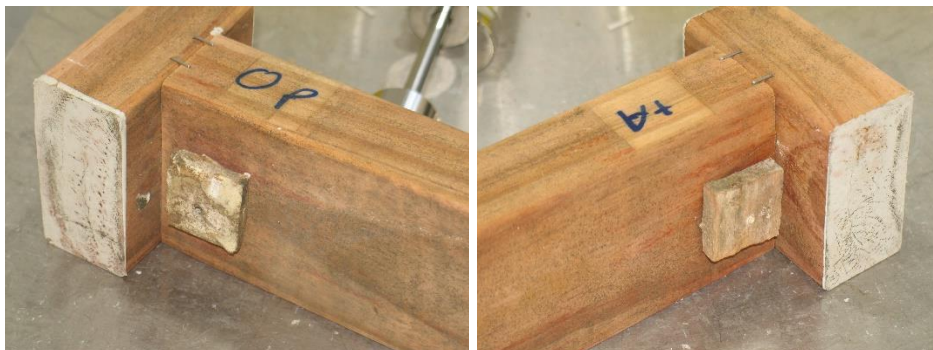
**Figure 14:** No decay and moderate mould on a boron treated radiata pine sample after one year's exposure (sample 80).

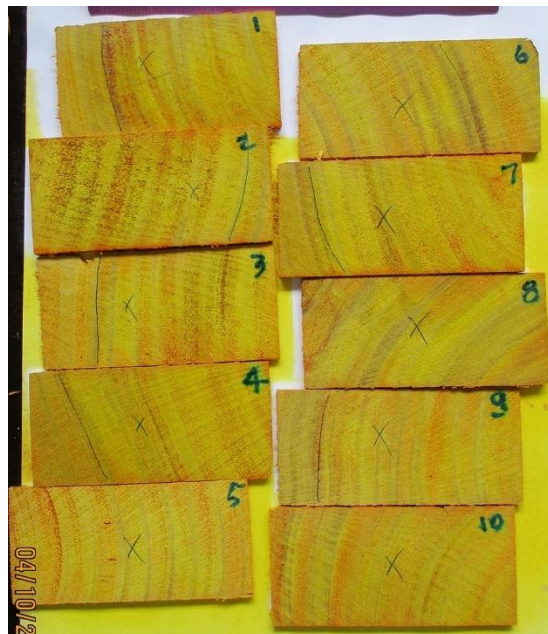
**Figure 16:** Penetration \sap spot test images of *Eucalyptus fastigata* in cross section

The sapwood\heartwood spot tests showed that all *Eucalyptus fastigata* solid wood samples were predominantly heartwood (Figure 15). The penetration spot test showed poor penetration of boron wood preservative (Figure 16). None of the *Eucalyptus fastigata* solid wood samples achieved the retention of 0.40 %m/m.

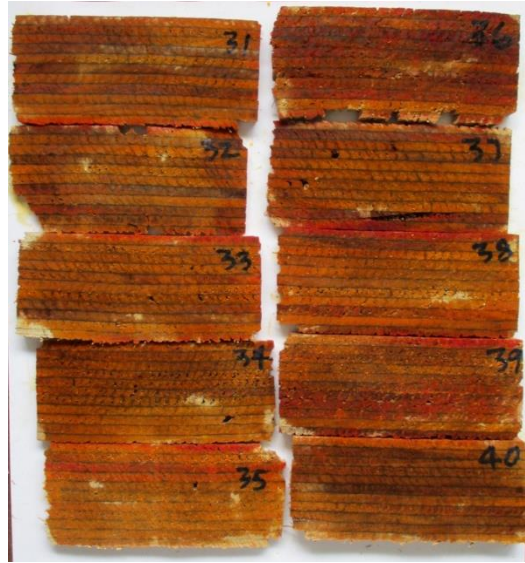
**Figure 17:** Heart\sap spot test images of *Eucalyptus fastigata* LVL in cross section

The sapwood\heartwood spot tests showed that the *Eucalyptus fastigata* LVL samples contained high levels of sapwood, (Figure 17). The penetration spot tests for the *Eucalyptus fastigata* LVL showed poor penetration of boron wood preservative (Figure 18). None of the *Eucalyptus fastigata* LVL samples achieved the retention of 0.40 %m/m.

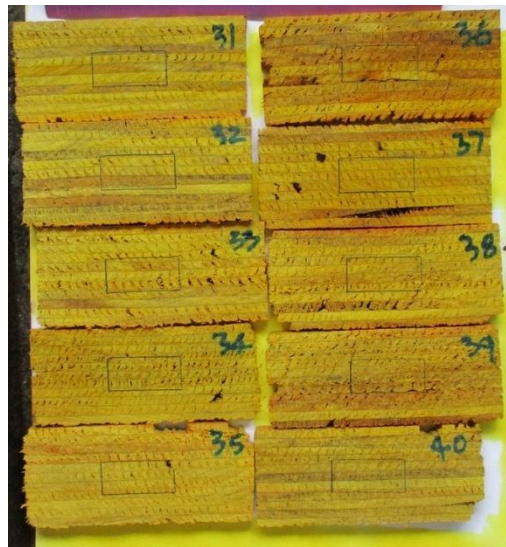
**Figure 18:** Penetration \sap spot test images of *Eucalyptus fastigata* LVL in cross section

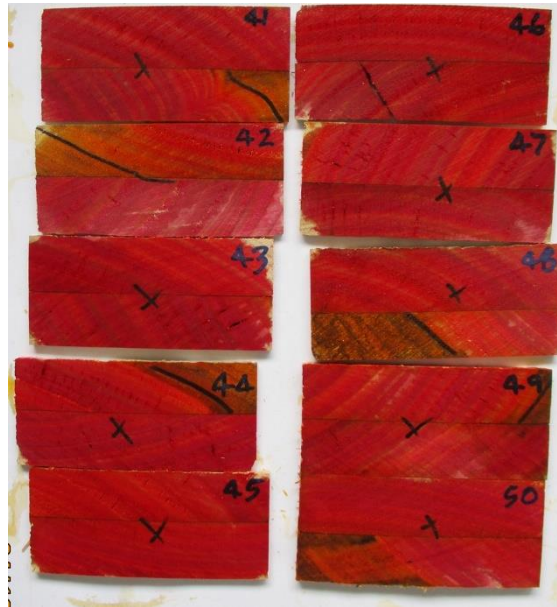
**Figure 19:** Heart\sap spot test images of laminated *Eucalyptus nitens* in cross section

The sapwood\heartwood spot tests showed that the *Eucalyptus nitens* samples were predominantly heartwood, although this varied between the two laminates in each board (Figure 19). The penetration spot tests for the *Eucalyptus nitens* showed good penetration of boron wood preservative from the quarter sawn edges (Figure 20). All of the *Eucalyptus nitens* samples achieved the retention of 0.40 %m/m, with majority exceeding 0.40% m/m boron retention.

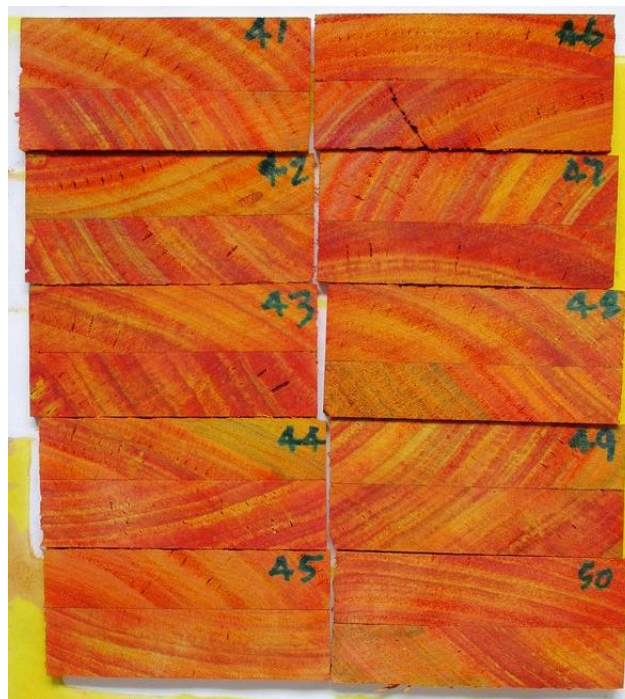
**Figure 20:** Penetration \sap spot test images of laminated *Eucalyptus nitens* in cross section

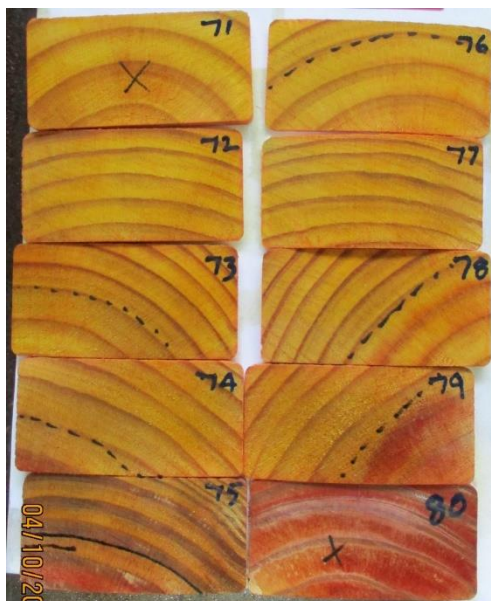
**Figure 21:** Heart\sap spot test images of radiata pine in cross section

The sapwood\heartwood spot tests showed that the radiata pine samples were predominantly sapwood, but two samples were completely heartwood (Figure 21). The penetration spot tests for radiata pine showed good penetration of the sapwood with boron wood preservative (Figure 22). All of the radiata pine samples achieved the required specified (NZS 3640) retention of 0.40 %m/m and central ninth retention exceeding 0.01% m/m.

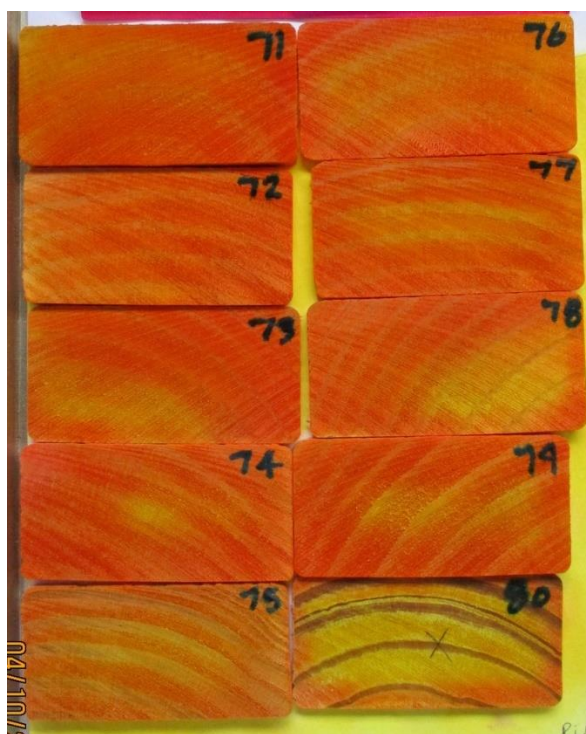
**Figure 22:** Penetration \sap spot test images of radiata pine in cross-section
